Photographs relating to proposed re-roofing works on the Church of Saint Joseph's Retford

Main roof of church photographed from the East.

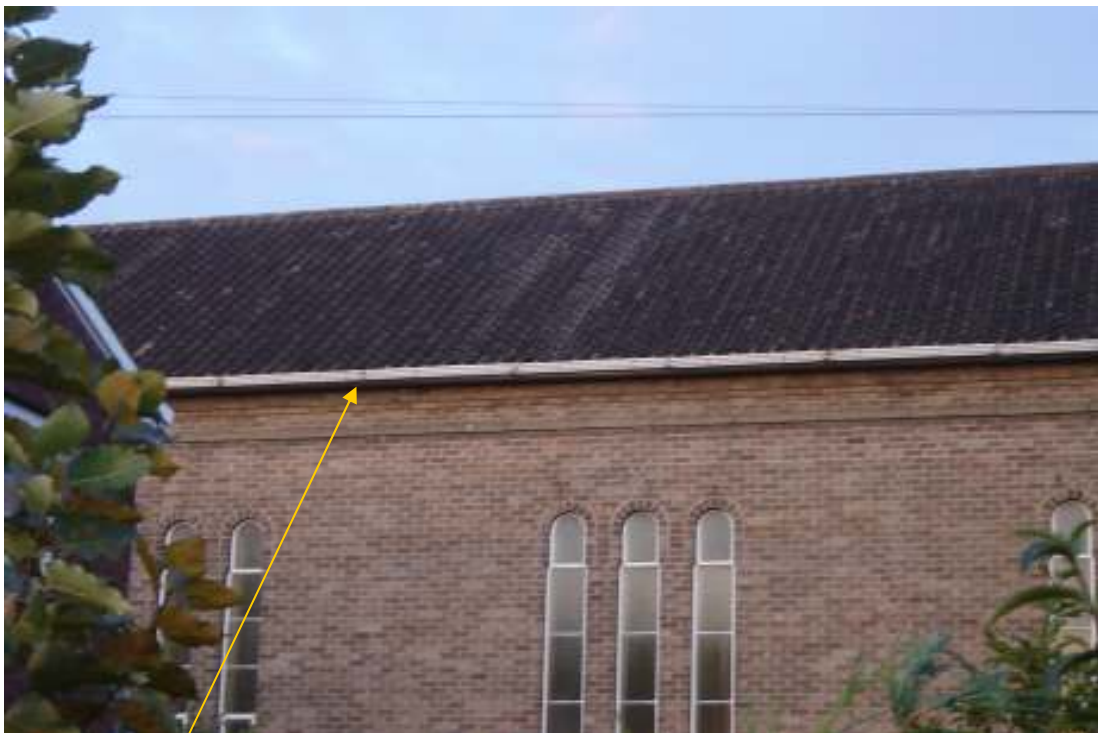
Main roof of the church east side.
Signs of corrosion can be seen on the gutters as well as repairing on main roof.
The main roof contains no insulation.

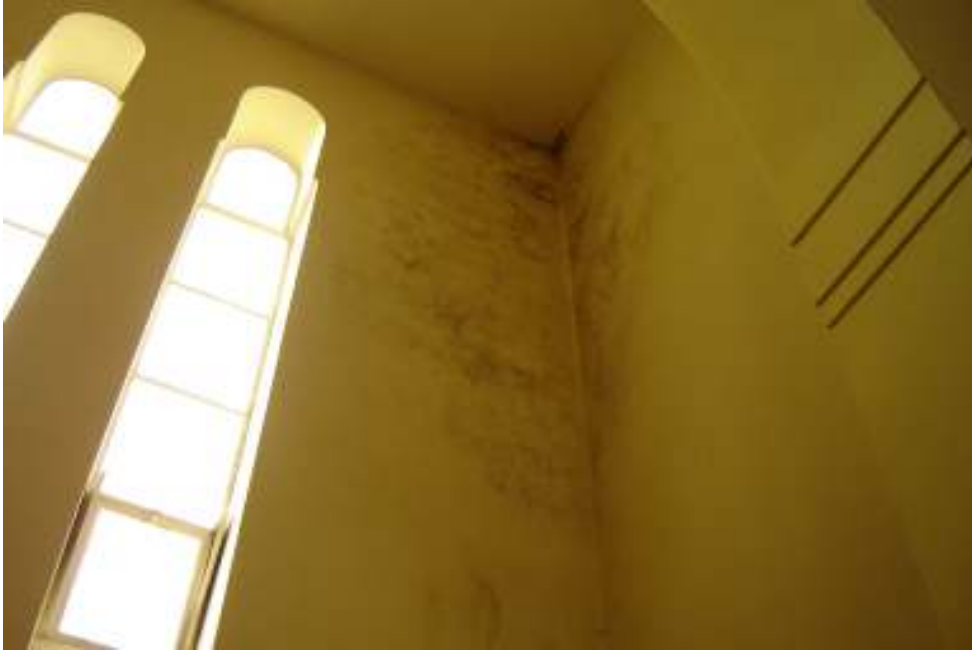
An area of damp on the north west corner of the church.

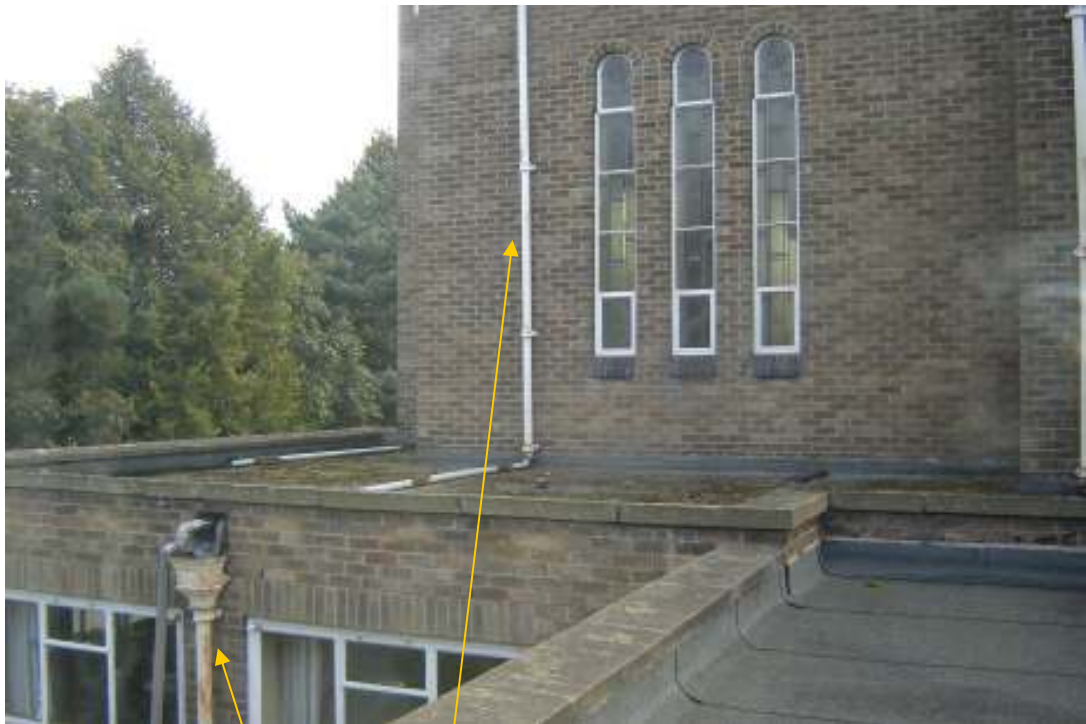
Flat roof north west corner of the church.
Notice conditions of downspouts.

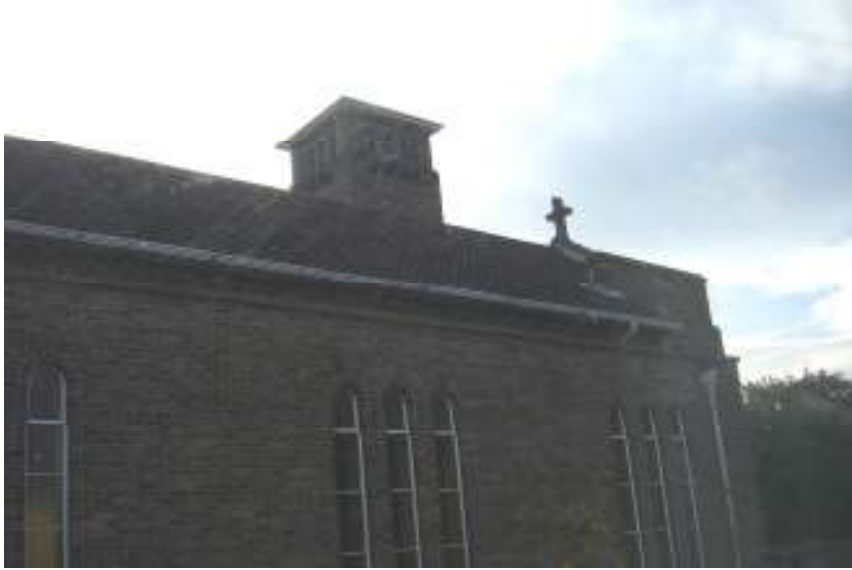
Another shot of the west side of church. Rainwater goods need to be replaced.

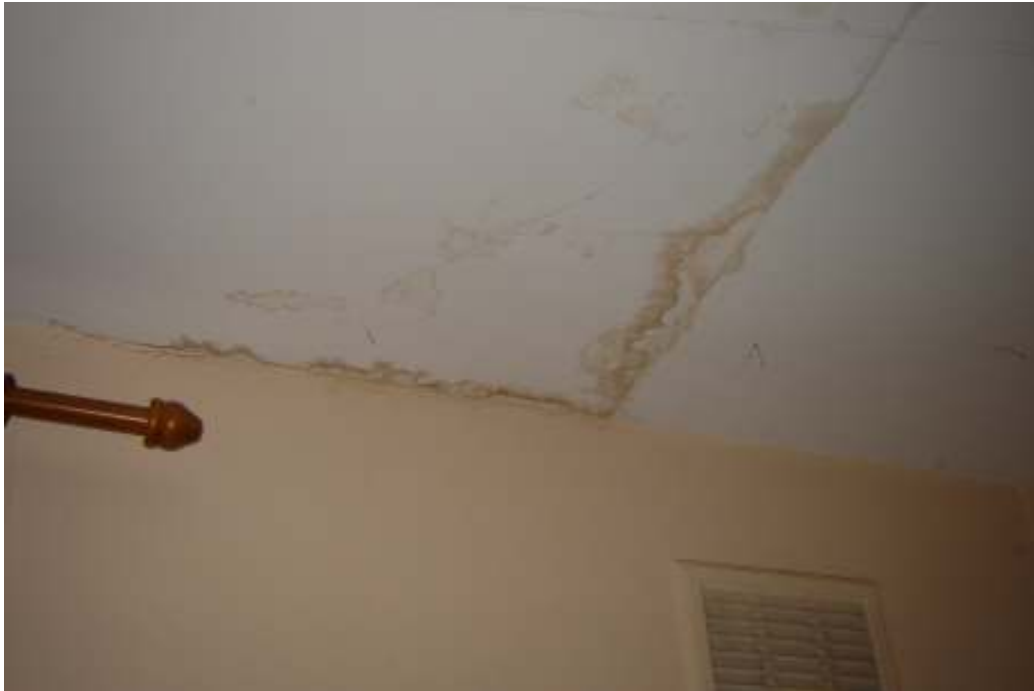
Damp in the sacristy.

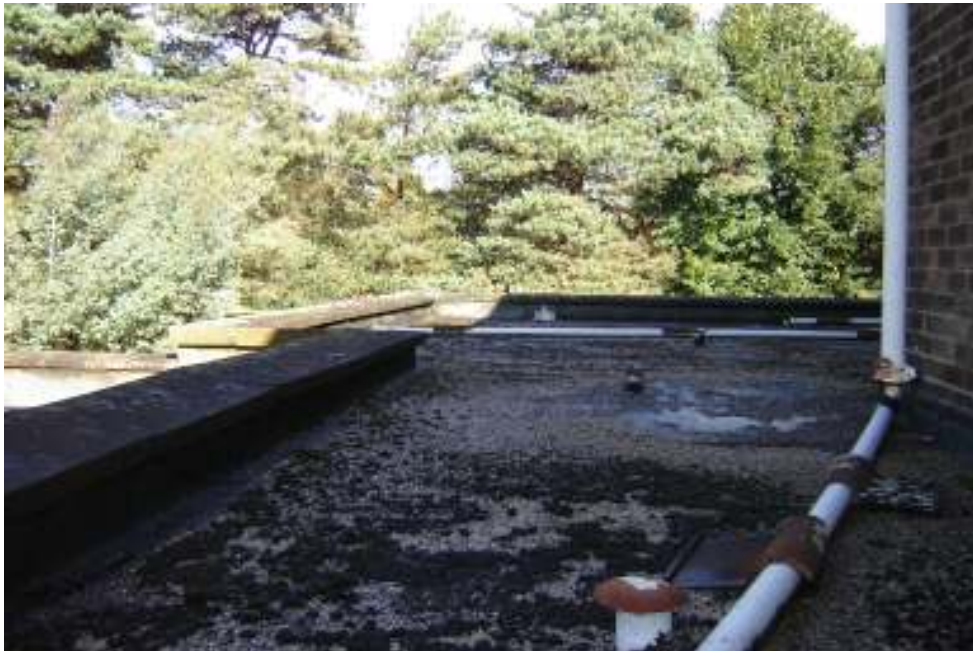
Flat roofs on the west side of the building.
There is evidence of bubbling and cracking.

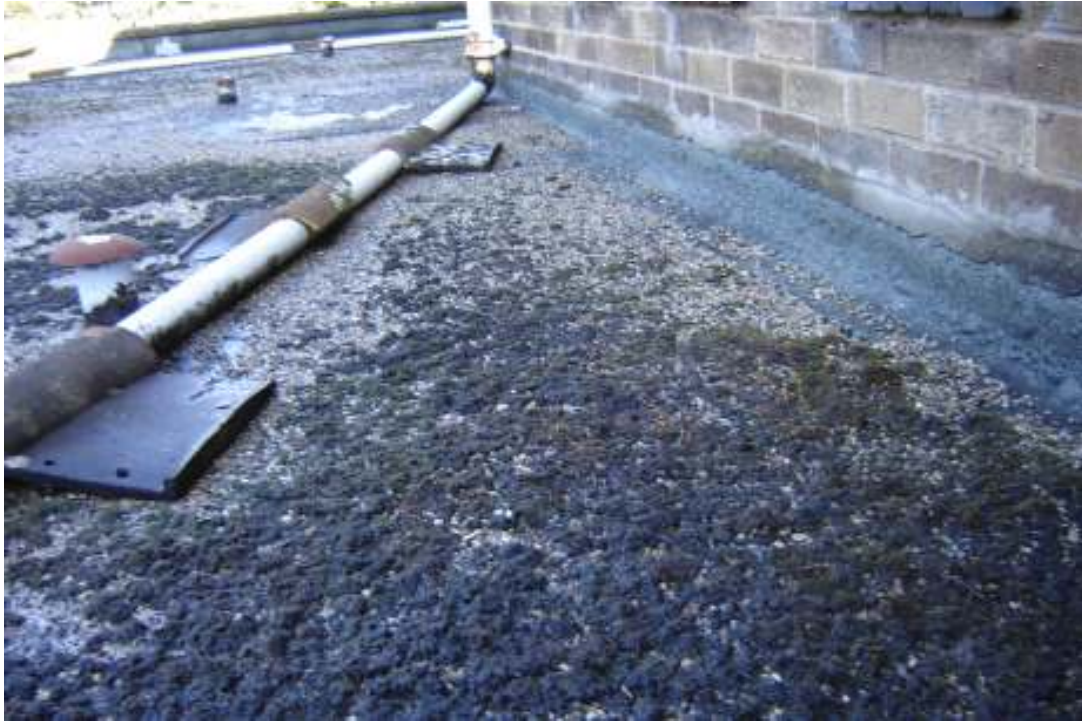
Flat roofs on the west side of the building.
